# Project Phoenix

Update 2 – May 31, 2015

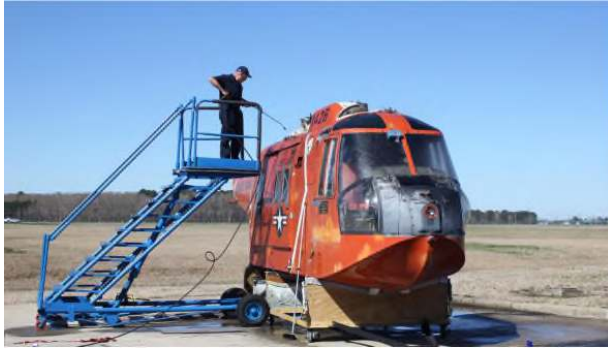
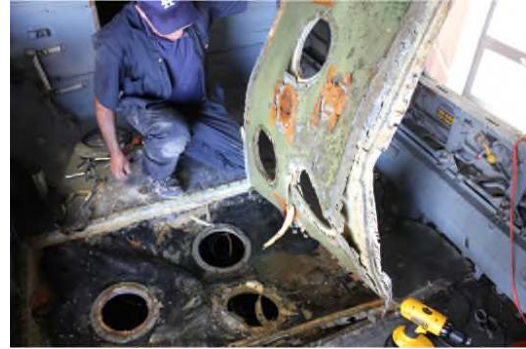
The meeting allowed all participants to raise concerns and ask questions regarding aircraft condition, authenticity, and requirements to meet Smithsonian standards. As you can see below, the aft cabin aluminum honeycomb floor required extensive repair.

The underlying fuel tank was purged and removed, revealing a fiberglass “bucket.” There was no corrosion on adjacent frames. The tank plumbing (fuel quantity probe and jet pump) was cleaned and replaced. Extensive skin corrosion at numerous areas on the hull was identified. The decision was made to induct 1426 into a “media blast” procedure (formerly called “bead blast” but in modern times they use ground corn cob) to remove all exterior paint, in order to get a better look at the corrosion. Work began on obtaining a better floor panel from “the Aberdeen Girls” or 1398. Eventually the floor attachment flange needed to be reinforced and 60 new anchor nuts installed to make the floor secure.

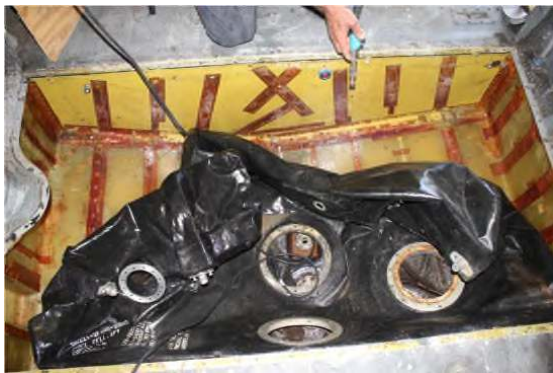
**Collapsed fuel bladder showing fiberglass**

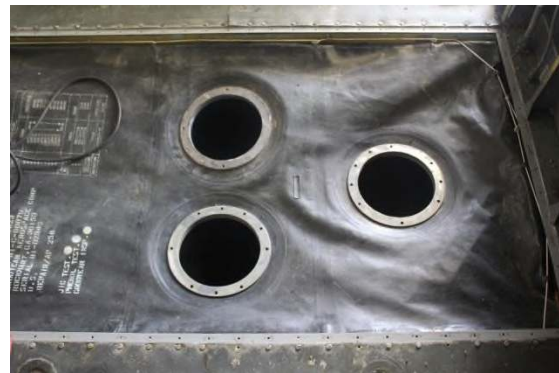
**Clean bladder ready to be re-installed**

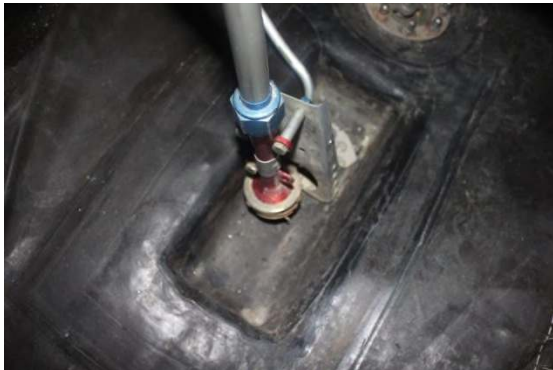
**Inside fuel bladder – “plumbing” re-installed**

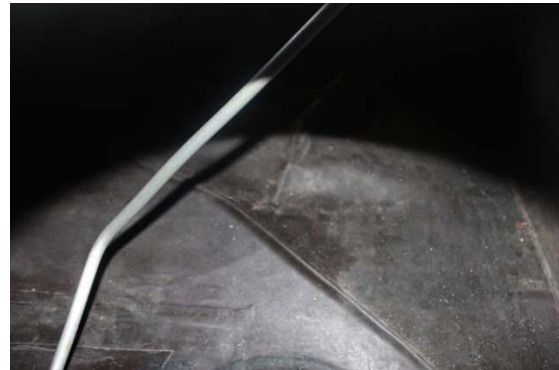
**Inside fuel bladder: clean, well preserved**

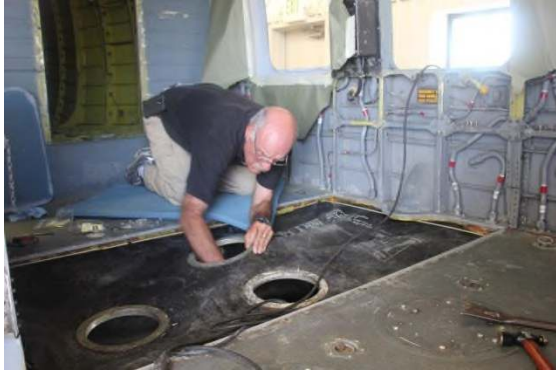
VectorCSP's Craig Simmons installing bladder

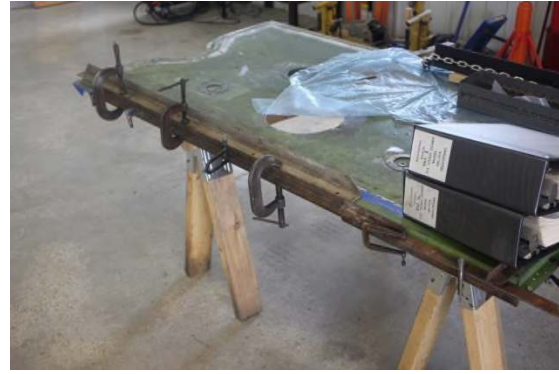
Floorboard flange repair

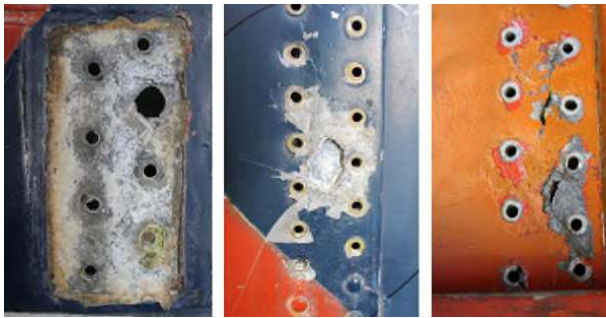
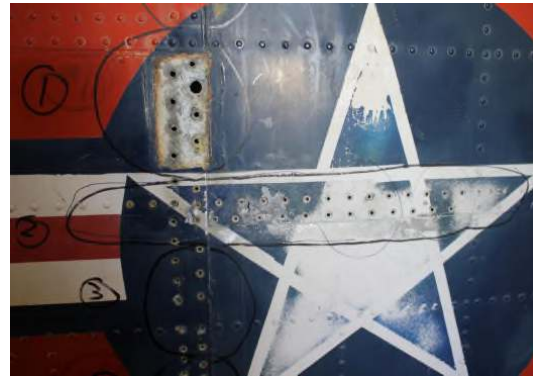
Inspection of 1426 revealed a number of locations where corrosion was present. Rivets were drilled out and the surface was prepared for patching. Hexavalent chromium (zinc chromate) is no longer permitted as an underlayment to protect airframes from corrosion. Below are some pictures of various locations that will undergo repair in June.

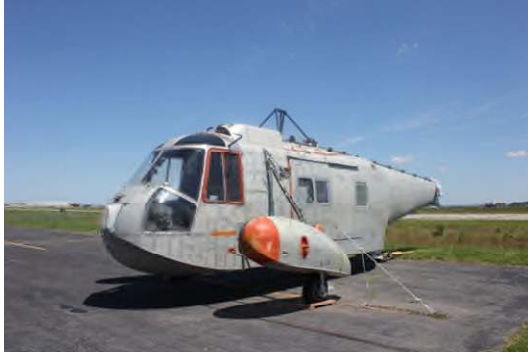
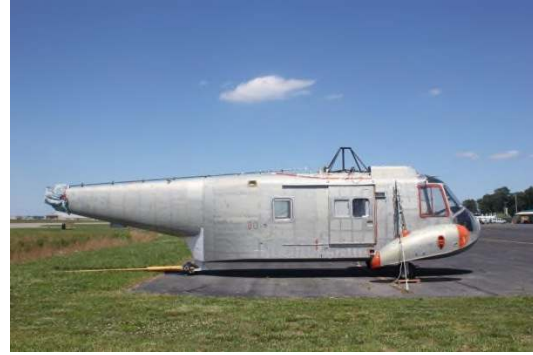
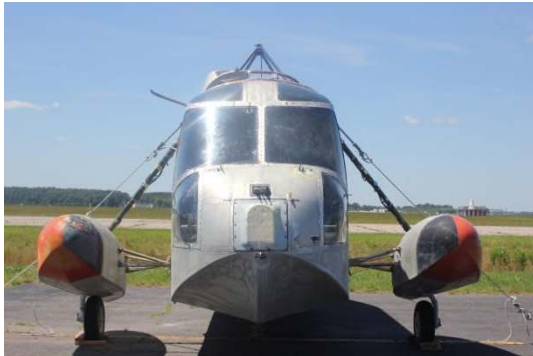
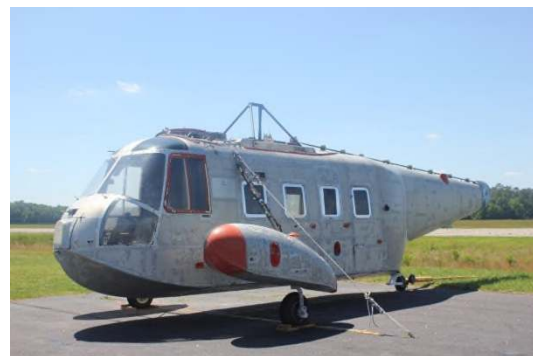
VectorCSP's John Siemens fabricated and installed a "transmission truss" to hoist 1426 and the sponsons were re-attached. On May 19<sup>th</sup>, 1426 entered media blast at ALC, thanks in large part to CDR Frawley authorizing an addendum to the Project Phoenix Memorandum of Agreement (MOA) and the support of CAPT Martin at ALC. The following are views of 1426 following media blast.

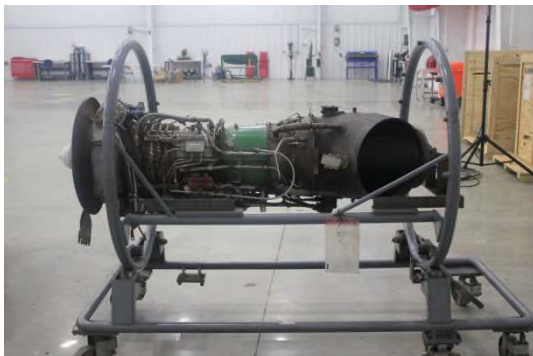
**Right side view of engine (correct view)**

One senior officer commented, “She came out looking better than some of our fleet aircraft.” John Siemens welded up a structure to mount the General Electric T-58 engine on an Allison T-56 engine stand. This allowed the engine to be rotated 360 degrees for cleaning and polishing.

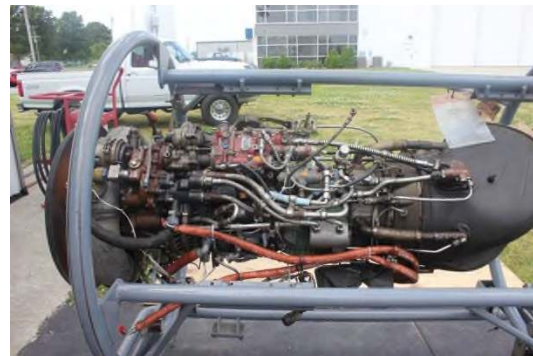
**Engine rotated approximately 135 degrees**

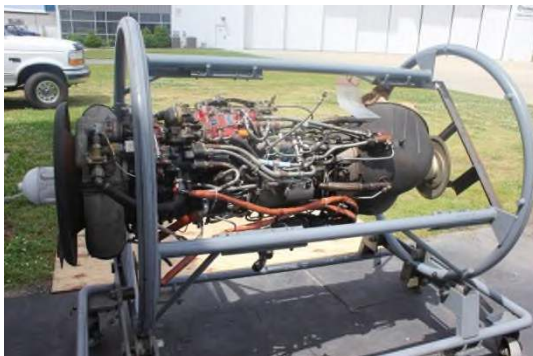
**Engine showing fuel control, oil lines, etc.**

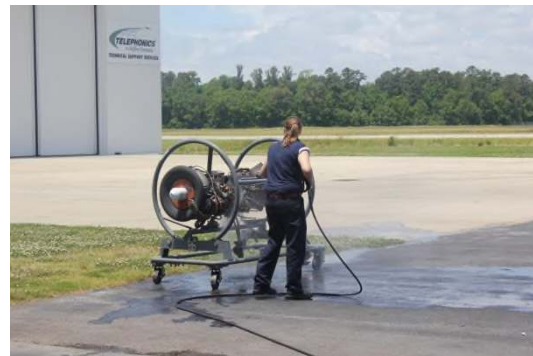
**Pressure washing engine**

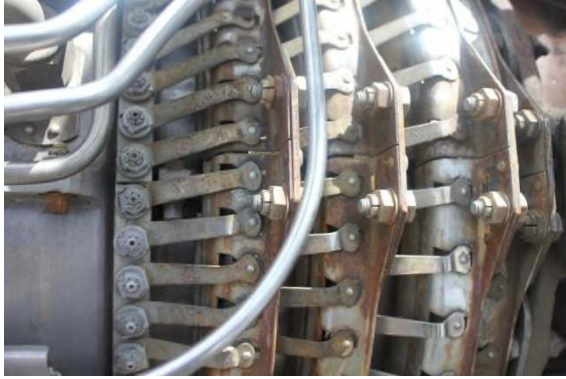
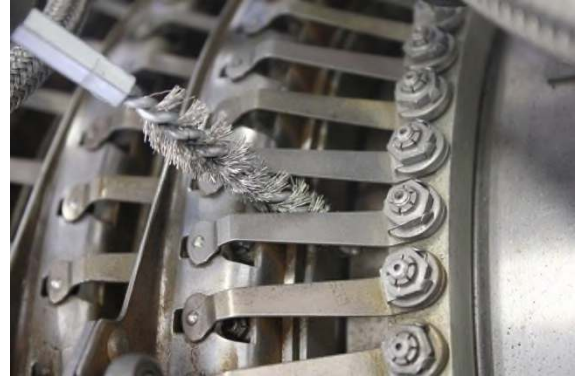
**As it turned out, there was considerable corrosion on the stator vane actuators. These were cleaned with solvent and wire brush.**

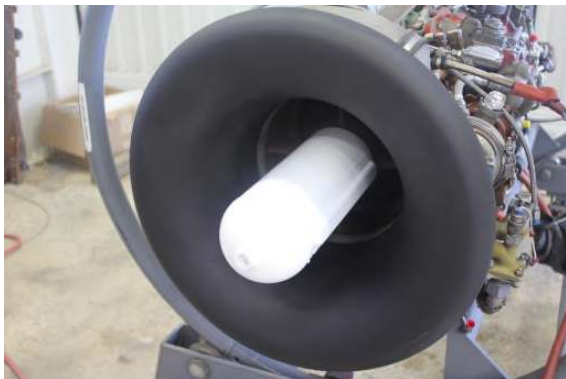
**The starter housing re-painted gloss white... and intake bellmouth re-painted flat black**

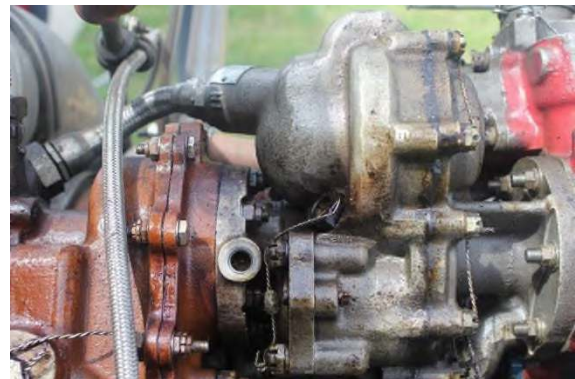
**Engine accessory section in good condition**

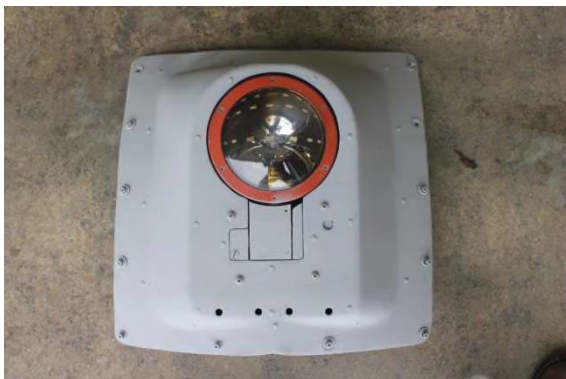
**Nose searchlight following stripping of layers**

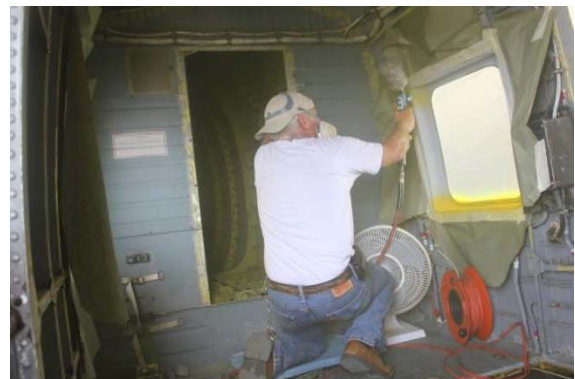
**Re-painting emergency exits after strip/prime**

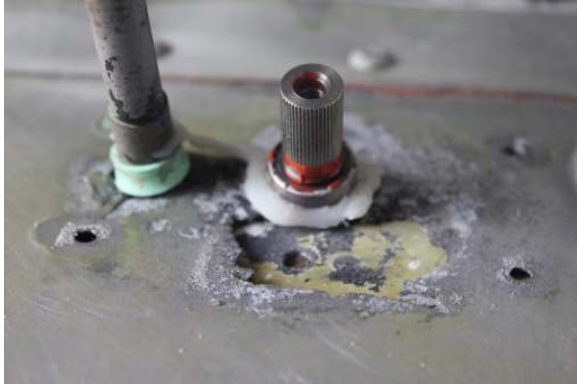
**Windshield wiper mounting stud**

**Many areas of corrosion were detected after media blasting. These will be addressed in June. A solicitation message has been sent to the fleet requesting two active duty volunteers per week to assist in performing corrosion repairs. This will give the volunteers, particularly those with only composite repair experience, some expertise in metal work. In addition, there are numerous areas of fiberglass housings or fairings (sponson struts, Schrader valve fairings, fuel vents, tail pylon, etc.)**

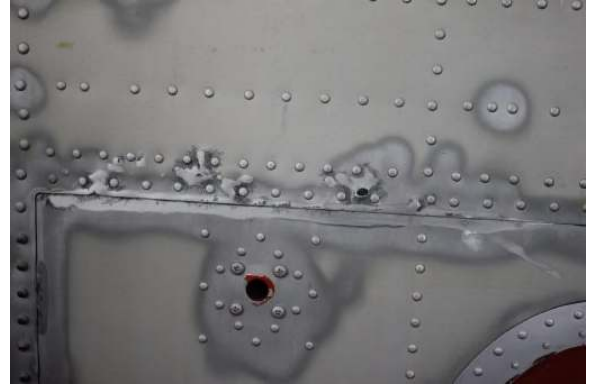
**Skin eroded between rivet pattern**

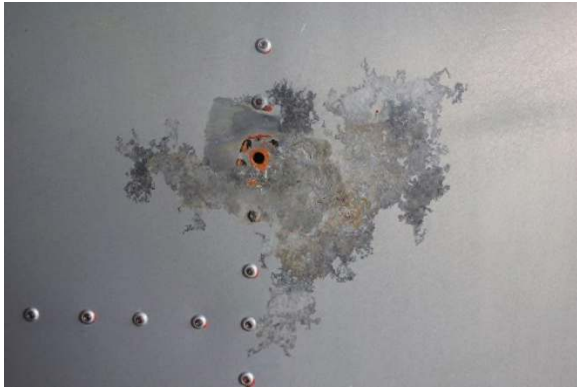
**Corrosion on sponson float bag attachment point**

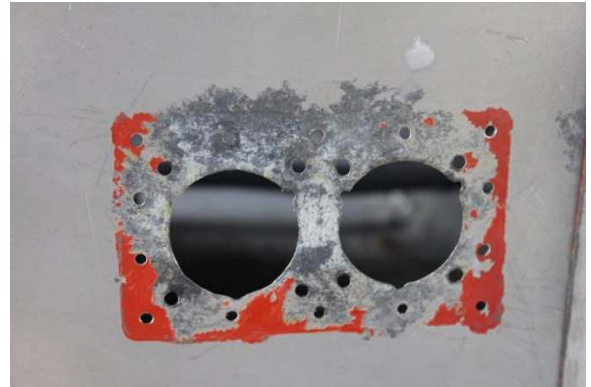
**Easily repairable corrosion (not foreseen)**

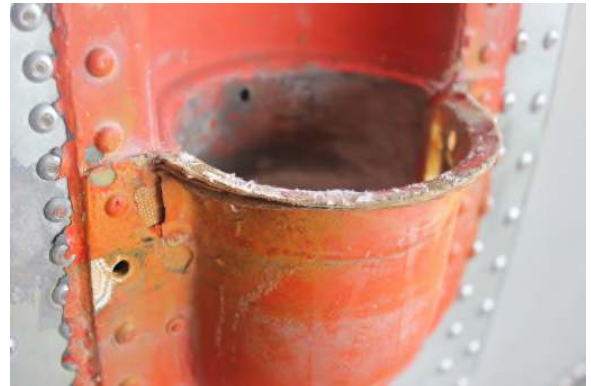
**Sponson anti-collision light housing**

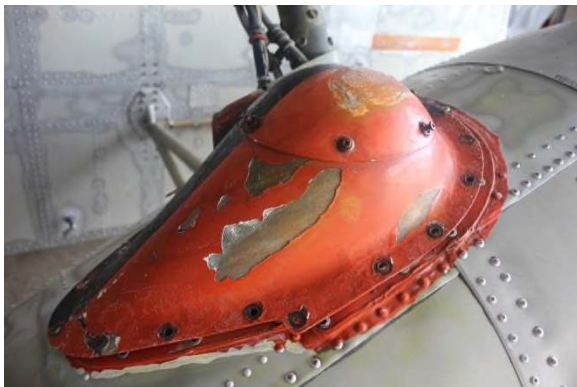
**Schrader valve housing**

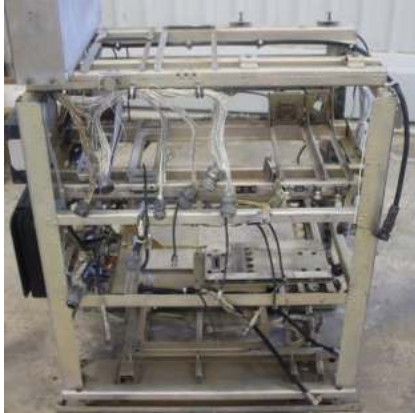
**"Like new" avionics rack"**

- Sand-blasted rescue platform
- Moving avionics black boxes from original 1426 radio rack to a far better one (depicted above); cleaned all "black boxes" and "fogged" with black paint – they look great!

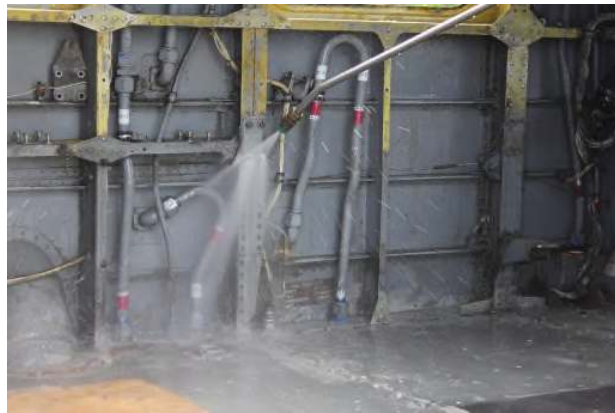
**Cleaning cabin deck and bulkheads**

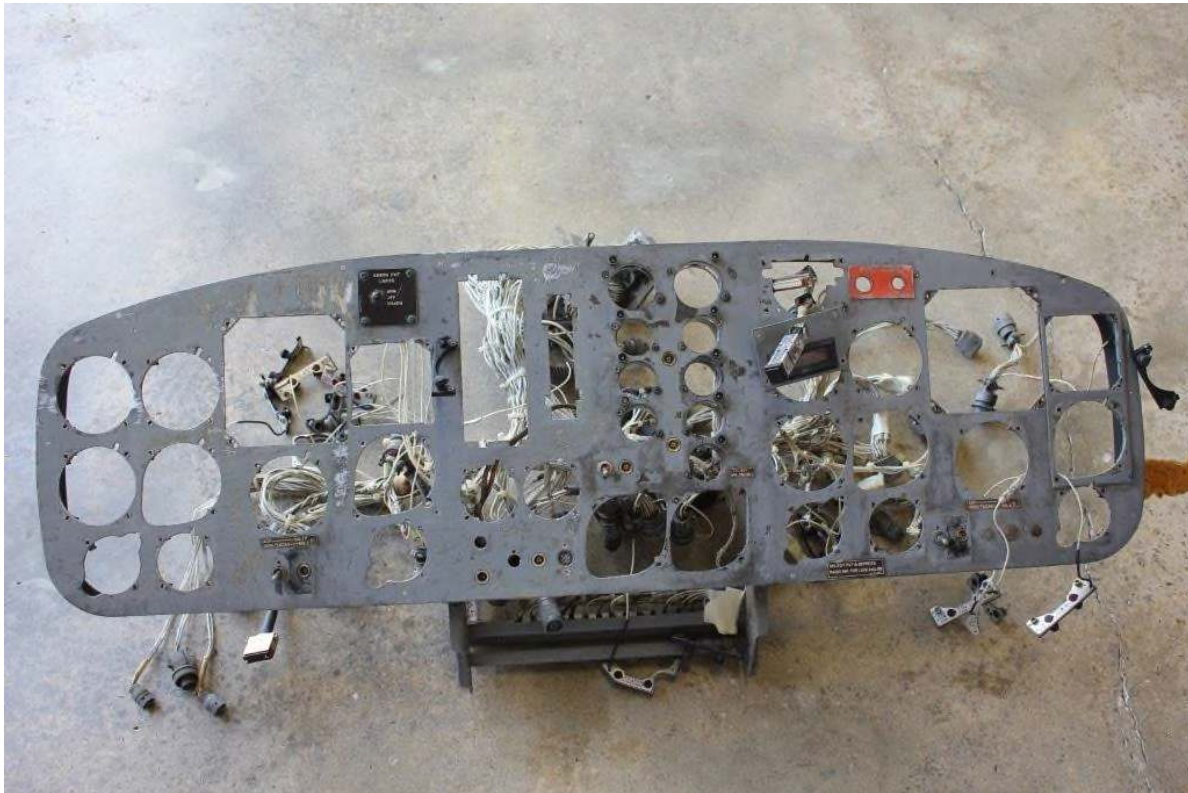
**Instrument panel to be sand-blasted and all instruments cleaned, re-installed**

- Cockpit totally gutted – found and repaired minor corrosion on floor
- Instrument panel removed and sand-blasted; all instruments removed, cleaned
- Second trip to wash rack; scrubbed cockpit and cabin

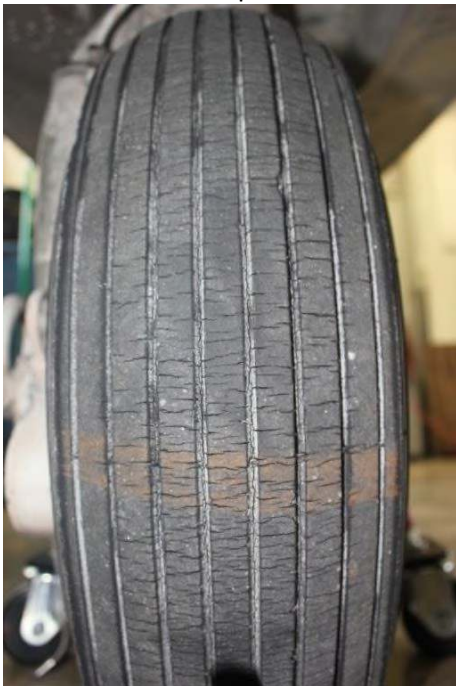
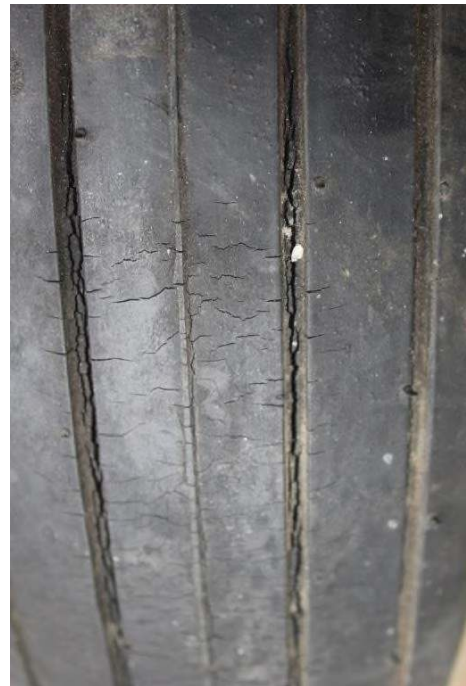
- Inspected MLG wheels and tires (tail wheel and housing previously done); attempted to inflate tire to appropriate PSI – tire showed huge cracks; tires will likely need to be replaced – looking at cost/effective solution
