Project Phoenix

Update 3 – June 14, 2015

Here's another progress report on HH-52A 1426. CAPT (ret) Ray Miller (Phoenix Project Manager); CAPT (ret) Mont Smith (CGAA Executive Director's Representative); and CAPT (ret) Tom King (Special Projects, VectorCSP) traveled by automobile to meet CWO4 (ret) Bill Kopp, (Director of Operations, VectorCSP); CAPT (ret) John Siemens (Technical Subject Matter Expert, VectorCSP); and CWO4 (ret) Craig Simmons (Technician, VectorCSP). We also gave interviews to, and encouraged photography of ongoing efforts by reporter Bill West of the Elizabeth City Advance newspaper. The idea was to promote interest in our project by citizens of the adjoining North Carolina counties, many of whom were either employed by USCG Aviation Repair and Supply Center or its modern day successor, the USCG Aviation Logistics Center. A great many former employees who worked the AR&SC H-52 Repair Line were directly involved in the Programmed Depot Maintenance (PDM) process. Their experience and advice is considered invaluable. In addition, their pride in overhauling each H-52 every 42 months was reflected in the operational availability and performance of the aircraft. We hop

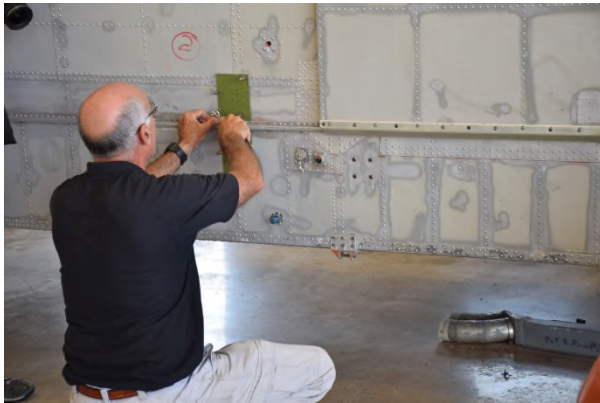
We mentioned in the previous update that the month of June would see considerable metal and fiberglass repair aimed at fuselage and sponson corrosion control. Here, Craig Simmons is riveting a small patch on the starboard hull just aft of the sliding cabin door frame. In the adjacent picture, you

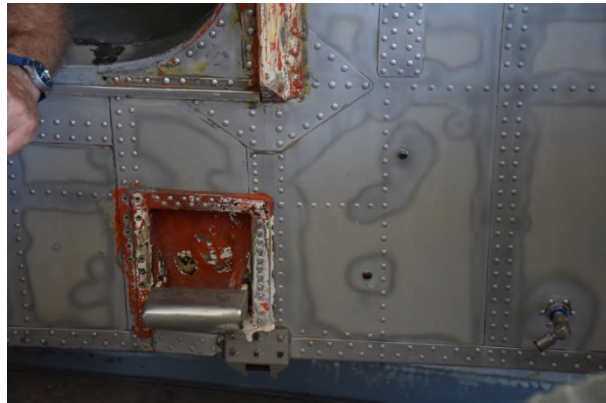
can see that the cabin step is severely corroded. In order to fully restore the step at PDM, the cabin floor would be removed and the unit's surrounding rivets would be drilled out. The fiberglass kick plate and metal step would be unbolted and replaced. In order to avoid unnecessary labor costs, Vector will address the exterior corrosion and make fiberglass repair, while simultaneously assuring that the step is structurally sound, without removing the cabin deck above the step. As you can see in the pictures below, Craig and John are seeking advice from ALC on methods for repair of aircraft skin (port side of cabin adjacent to emergency escape window). It is important to address skin that overlaps frames and stringers. Fiberglass repairs are complete on sponson noses and trailing caps.

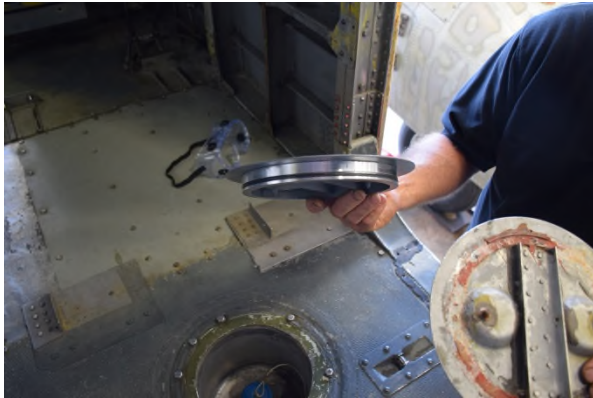
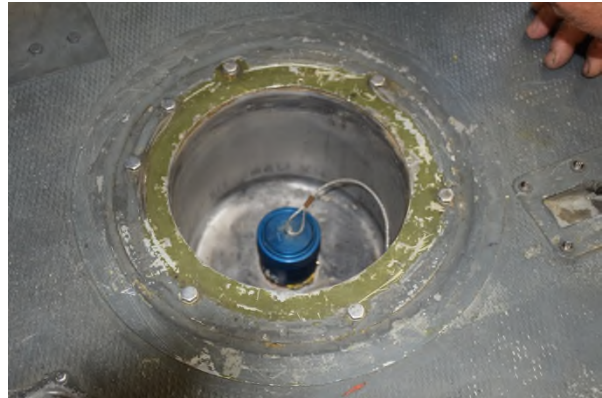
Considerable work has been accomplished on the cabin interior. John Siemens fabricated a “like new” interior fuel tank access cover. The old cover, flange and gasket were severely corroded. The cabin

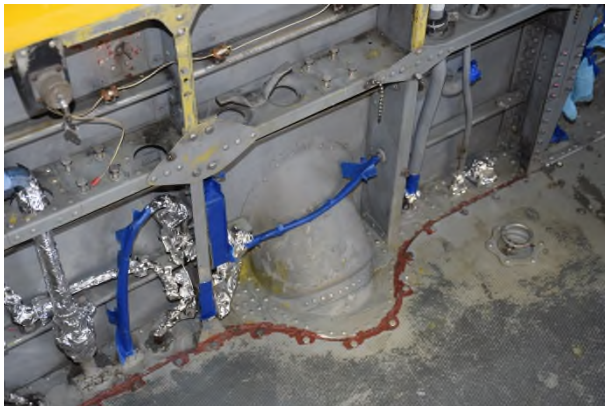
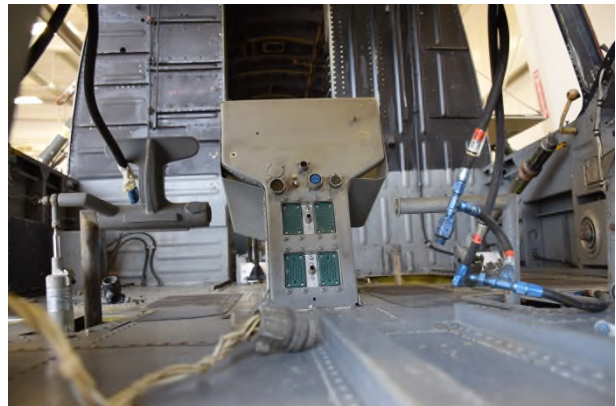
fuel tank access cover permitted Helicopter In-Flight Refueling (HIFR) by gravity feed nozzle from a WMEC or WHEC. You can easily see that the fitting in the HIFR well is in excellent condition. The

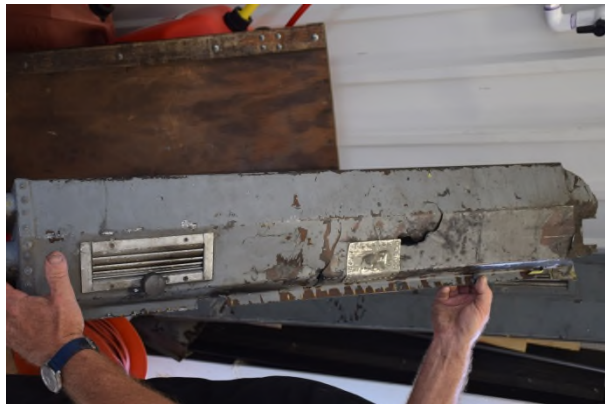
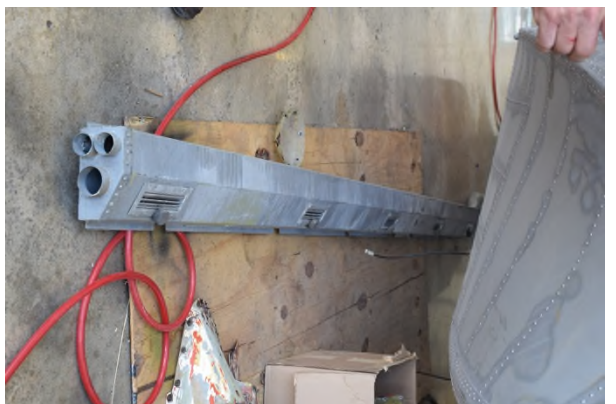
cabin deck and bulkheads are being prepped for painting in the near future. The plan is to re-paint the deck and surrounding bulkheads to a height of twelve inches with a gray paint matched perfectly to the original color. Above that height, the bulkheads will be “fogged” to eliminate “bleed through” from zinc chromate and to ensure conformity with existing paint in good condition. As you can see in the picture looking aft from the cockpit, bulkheads, anti-torque pedals and items like center console

are clean and in acceptable condition, showing a mere patina of fair wear and tear – as an H-52 would

appear in service on the flight line. The original damaged magnesium heater ducting (above left) will be replaced with a duct in great shape from the Aberdeen Girls/1398. We toured a T-Hangar where many of the sub-assemblies are being re-conditioned in preparation for re-installation in the near future. The avionics rack is 95% complete, missing only the AN/ARM-25 TACAN and a VHF transceiver. Incidentally, this rack, in pristine condition, was obtained from a parts stash in Cochise, Arizona by Ptero Cecil Loter. Above (right) you see an upper shock mount for the radio rack, which had a

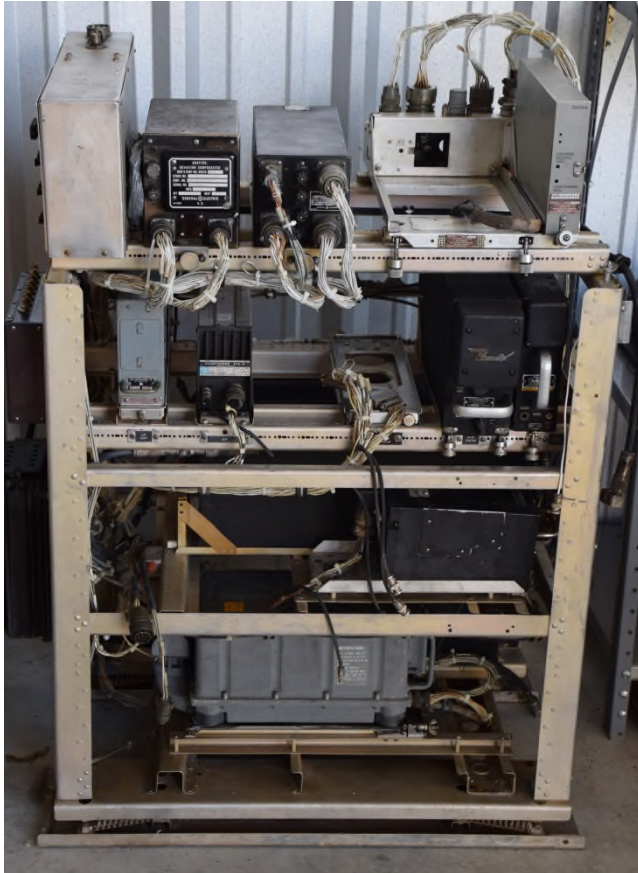
tendency to large amplitude vibrations in flight. John Siemens showed us the original avionics

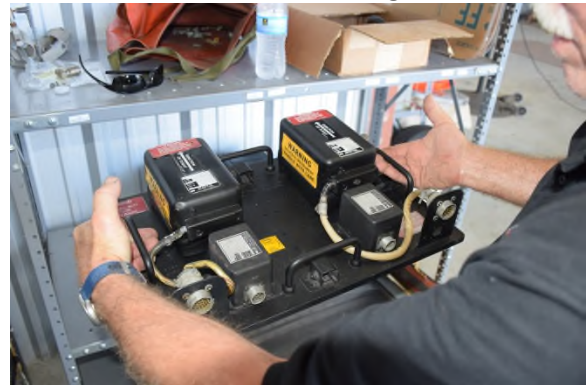
rack, which revealed a major area of burnished wear after a shock mount had evidently failed while the aircraft was in service. You can also see the gyro tilt table, which has been immaculately restored.

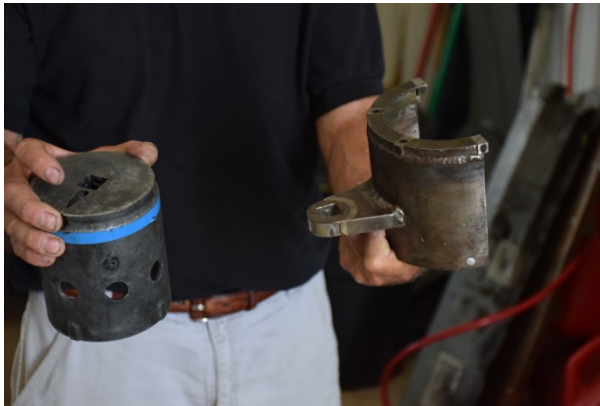
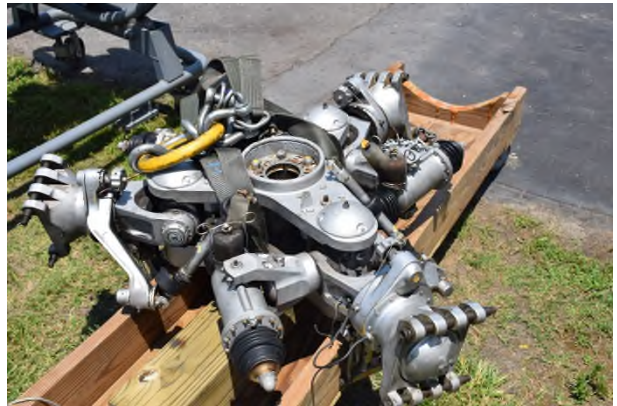
We are hoping for an active duty AST to volunteer to undertake repair or replacement of the cyclic, collective, and anti-torque pedal boots, as well as seat cushions, auxiliary float bag covers, troop seats and SAR board. Craig Simmons showed us the rotor head removal tools, which (used in conjunction

with a long steel bar to create 300 foot-pounds of torque) enabled VectorCSP to remove the rotor head from the splined transmission rotor shaft. Dampener boots and pitch change rod end covers will be inspected and renewed as necessary. "Tea kettle" hydraulic reservoirs will be drained. The "Jesus

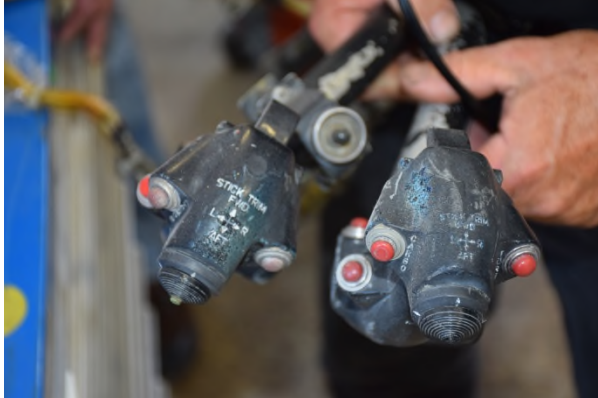
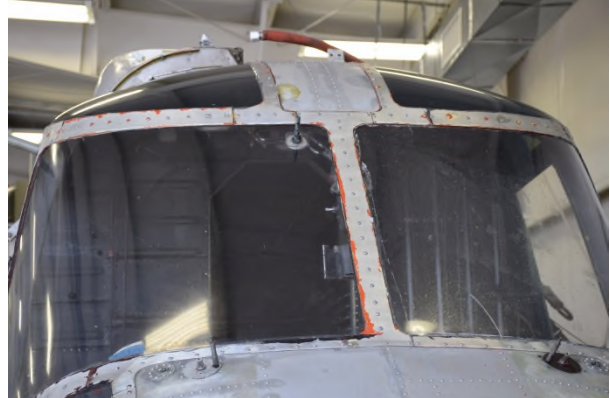
housing (swash plates, linkages, braces and hydraulic actuators. The remaining units on the accessory section (generators, hydraulic pumps, etc.) are in acceptable condition. Walking back to the FBO hangar, we saw both pilot's and co-pilot's "greenhouse" windows had been replaced and the co-pilot's windscreen crack had been stop-drilled. Corrosion control around windshield wiper mounts was addressed using a fix typically employed in the past by AR&SC. Both cyclic sticks showed evidence of chemical decomposition due to sunlight. We discussed several methods of restoration that will be discussed with Roger Connor, the NASM helicopter curator.

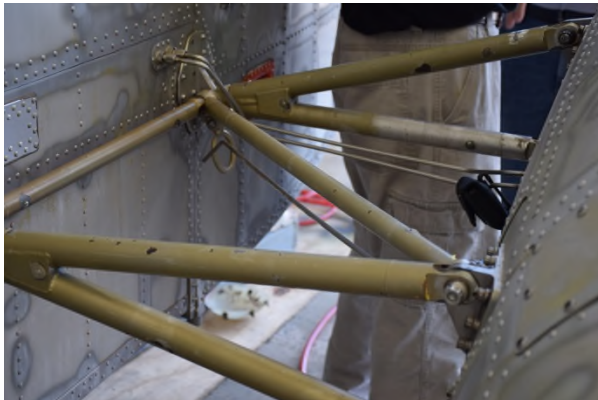
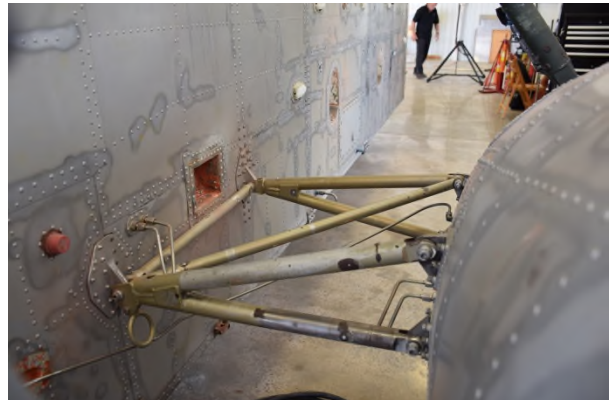
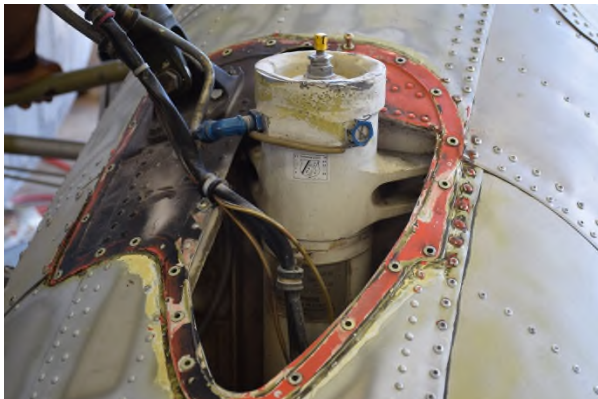
We inspected the horizontal sponson struts, which had been media-blasted and appeared to be in perfect condition and paint-ready. The Schrader valve atop the right main landing gear was free of corrosion and only needs layered paint removal. This update demonstrates that the 1426 restoration
