Project Phoenix

Update 7 – November 5, 2015

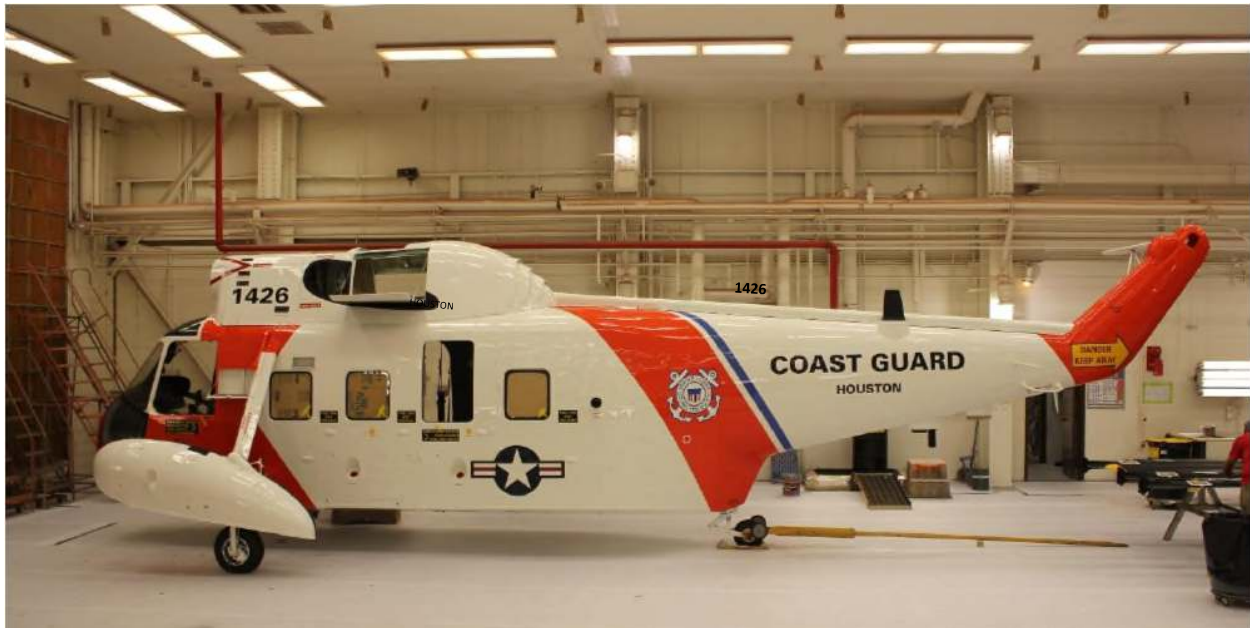
1426 departed the paint hangar on 5 October for USCG Heavy Maintenance Facility (HMF), Bay 3. The VectorCSP team completed installation of the port side cabin emergency escape hatch Plexiglas window. The hatch was returned to the paint hangar for painting of the missing emergency egress stencil on the interior of the hatch. The original seal that was removed prior to media blasting was glued to the hatch. The cabin sliding door was installed and lubricated.

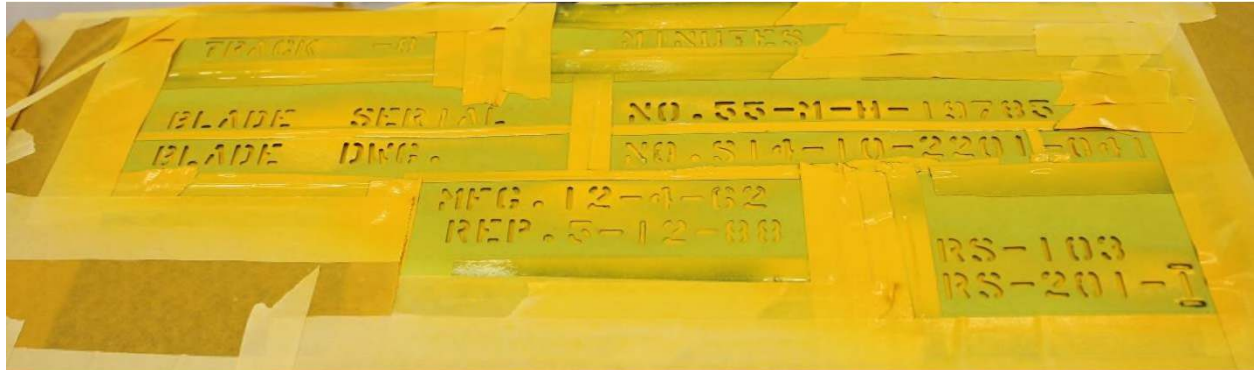
Several blades show dates of manufacture which preceded the HH-52, which means they likely flew on the HH-19/HO-4S. Dimensions of the blades were provided to the ALC warehouse for fabrication of new shipping crates.

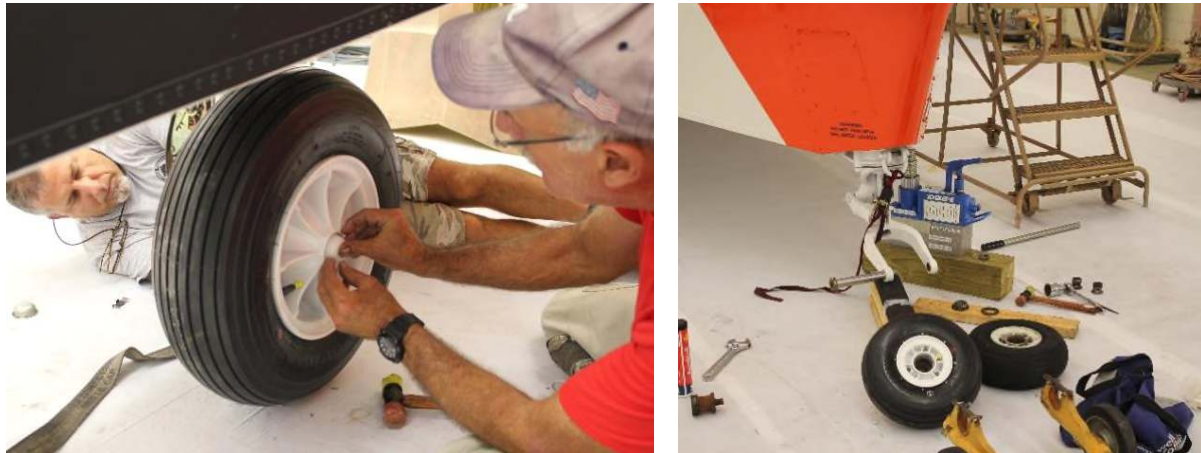
The aircraft was Jacked aircraft and the team replaced all wheels with new tires and tubes (donated by Goodyear). Bearings were lubricated and all corrosion was cleaned from the brake disks.

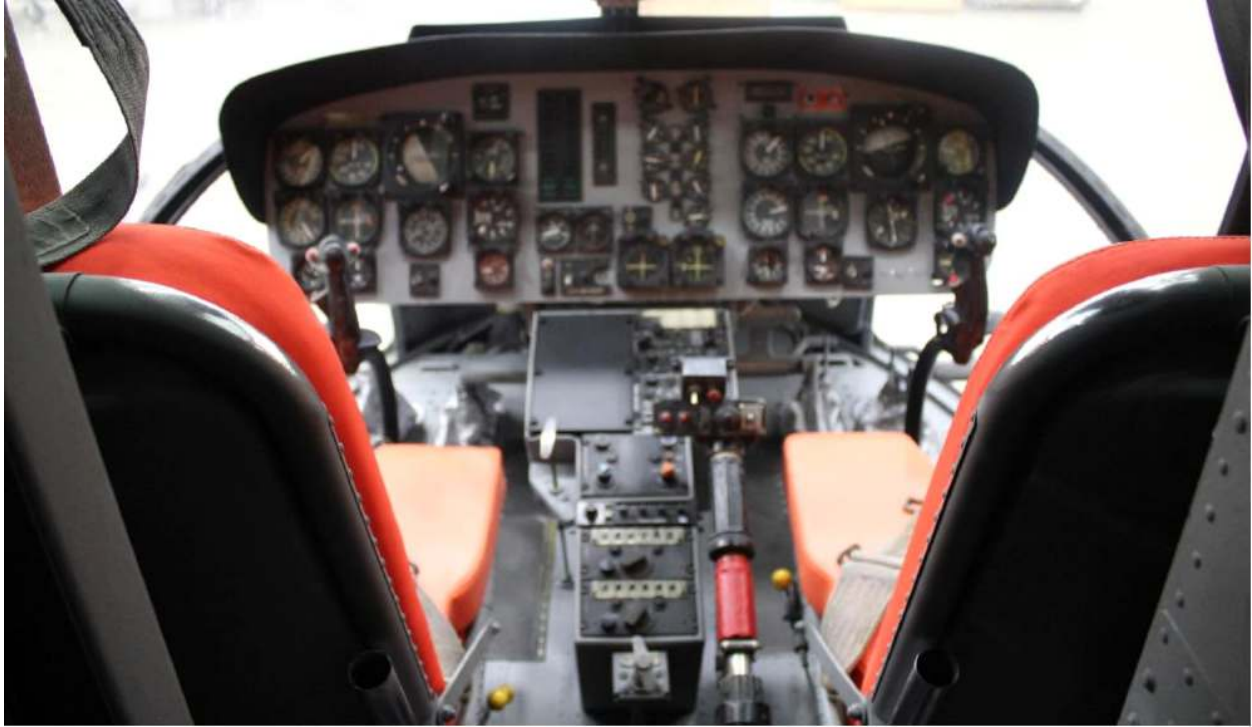
Pilot and copilot seats were painted, preserving wear marks (patina) made by personnel entering/departing the cockpit. Seat tracks were lubricated and seats were installed in the cockpit with new seat cushions. New bungee cords were manufactured for the seats. A broken shoulder harness inertia reel was disassembled and repaired.

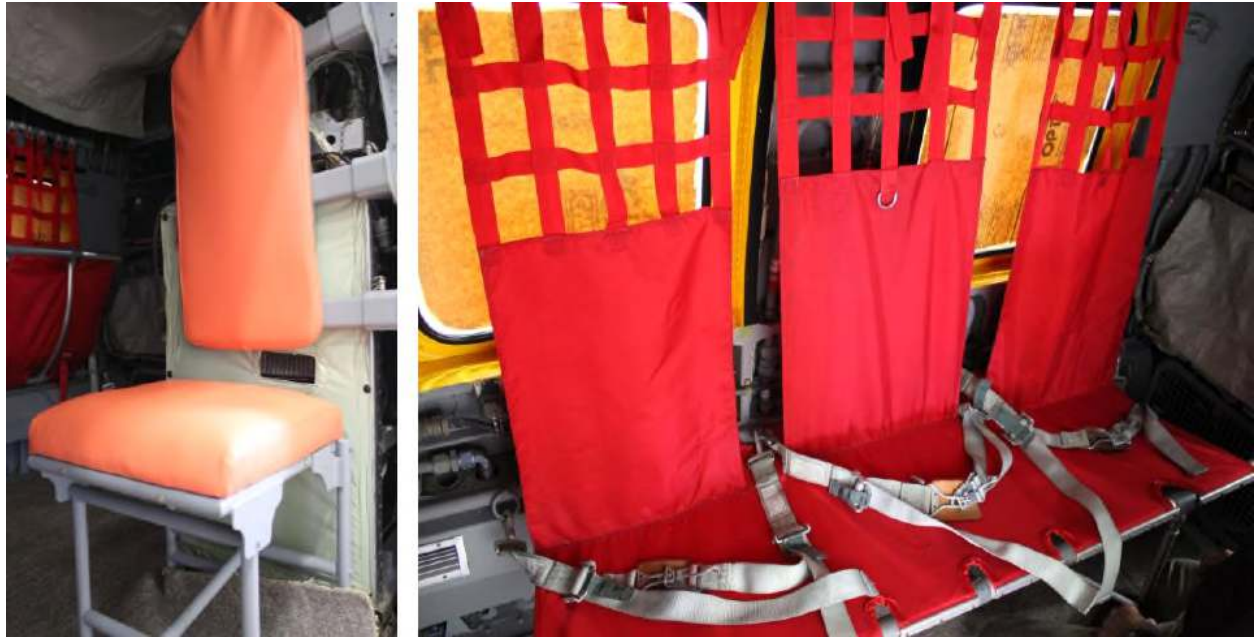
The flight mechanic seat board was sanded and repainted. The thickness of the seat cushion was reduced by the ALC upholstery shop to allow the seat to fold as designed, after which it was installed in the aircraft. The VectorCSP team removed corrosion, primed, and painted the upper and lower troop seat support tubes. They installed new troop seat webbing, and mounted the troop seats in the aircraft. Spring buttons in several of the troop seat support tube brackets were frozen and had to be replaced by functional brackets from the “Aberdeen Girls.”

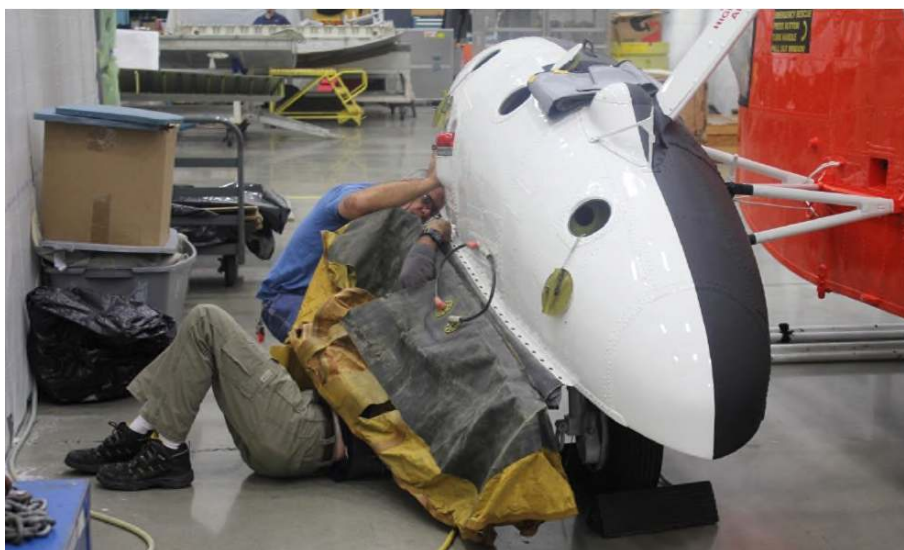
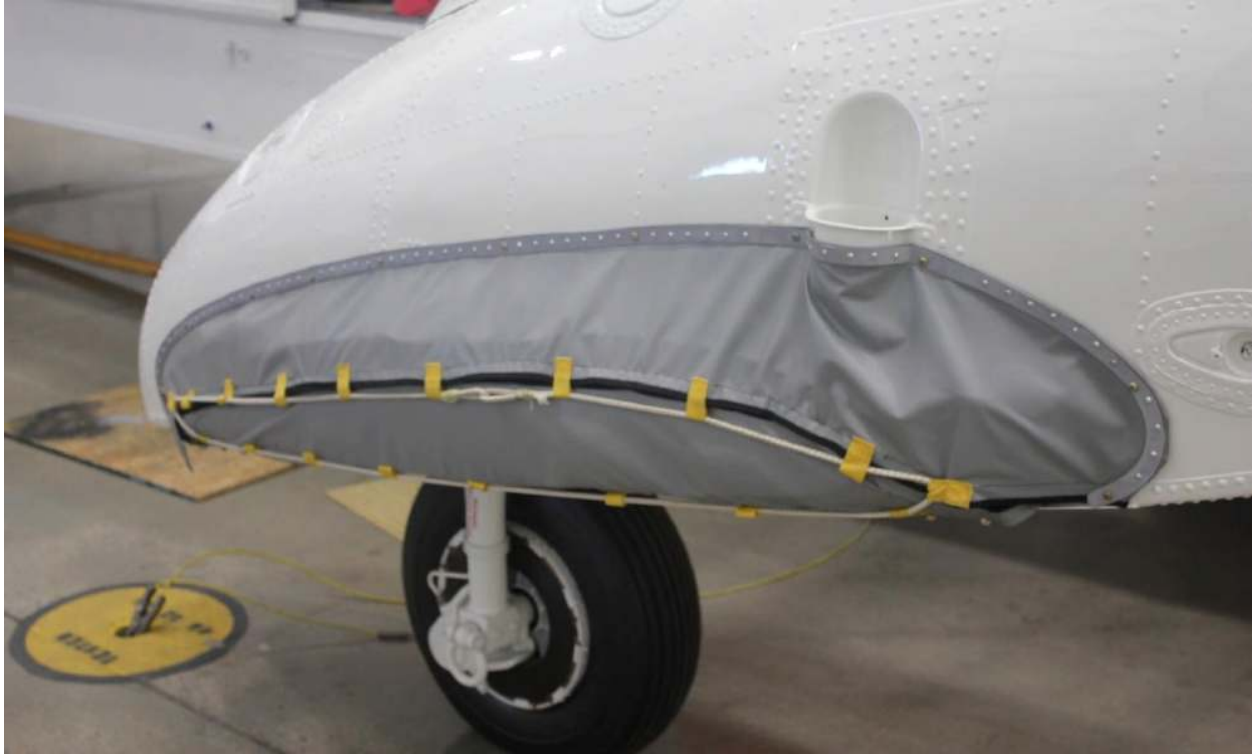
The team completed work on the float bags, with the exception of painting the upper and lower float bag retaining flanges. The float bag lower covers initially did not fit, requiring additional sewing. The starboard float bag was difficult to install. The port float bag upper cover flange broke during installation and had to be removed. The repair required drilling out all flange rivets to separate the flanges and removing the material. New flanges were cannibalized from the Aberdeen aircraft. The flanges were re-drilled to fit the 1426 sponson and underwent media blasting, priming, and riveting of the upper float bag cover to the flanges.
